AFRPL-TR-66-350

156-INCH DIAMETER MARAGING STEEL CASE  
HYDROBURST AND MATERIALS EVALUATION

TECHNICAL REPORT NO. AFRPL-TR-66-350

J. S. Coverdale,  
Norbert Wells,  
Gilbert Skopp  
George Brocker

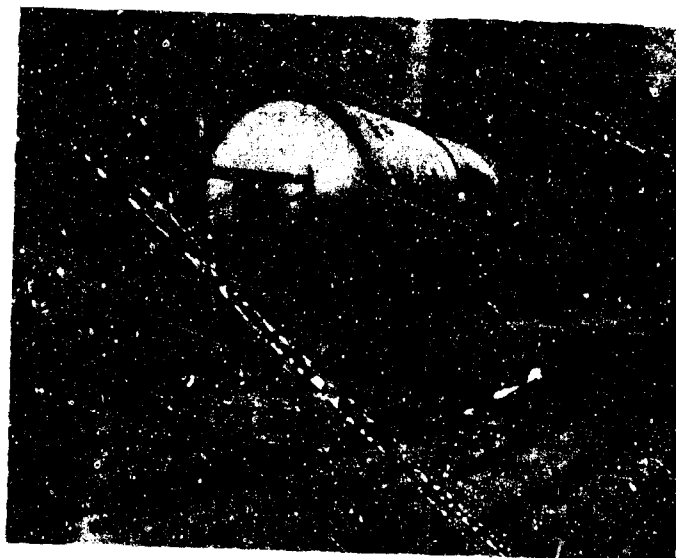
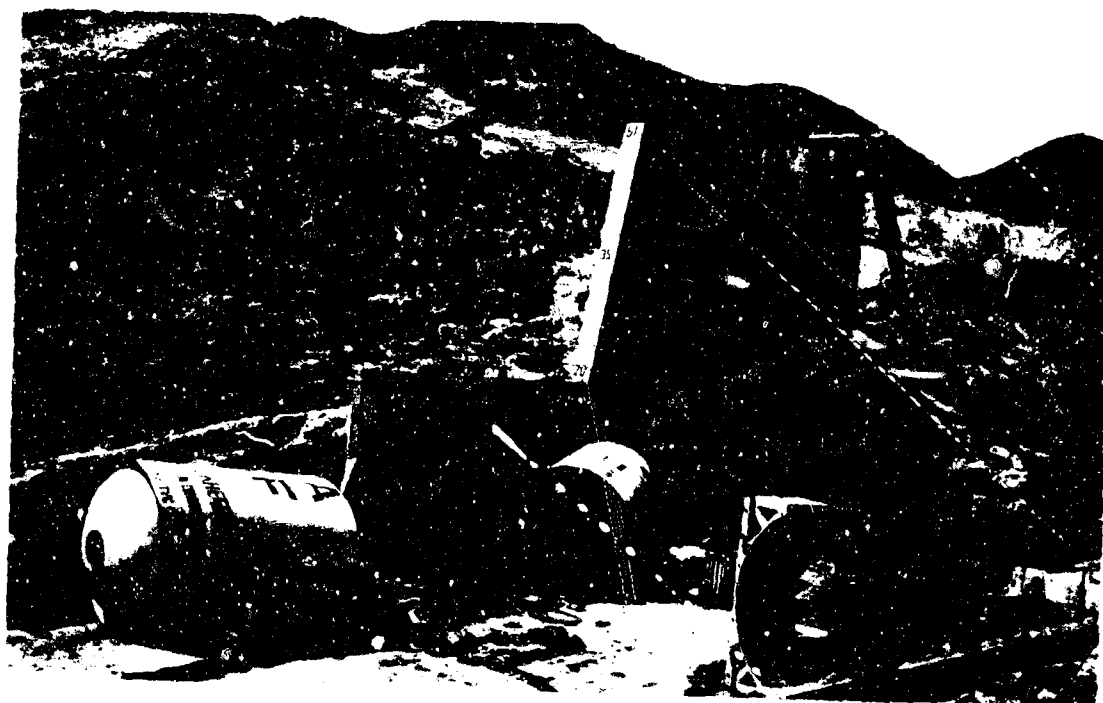
Figure 1 Pre-Test (a) and Post-Test (b) Hardware Arrangement

The adapter joint bolt circle was partially intact (see Figure 1); the adapter and bolts indicated a mixed tensile and tearing failure, with probable primary fracture damage to the adapter on impact with a proximate restraining cable. Of the 256 EWB 926-12-20 bolts, 133 showed tensile failure, 50 showed shear failure, and 73 remained in place. Concurrent evaluation by LPC, Mellon Institute, and SPS Laboratories was conducted. The three agencies concur in their findings of stress corrosion/hydrogen embrittlement damage to the bolts. The reports are included in Section V.

A reasonably specific sequence of events can be determined from the post-test hardware condition: (1) adapter failure, driving the motor forward skirt into the asphalt pavement, (2) movement of the motor upward into the restraining cables, creating severe ovality with cracking of the female joint at the lateral point of maximum curvature, and (3) sequential ejection of pins causing separation movement of the segments.

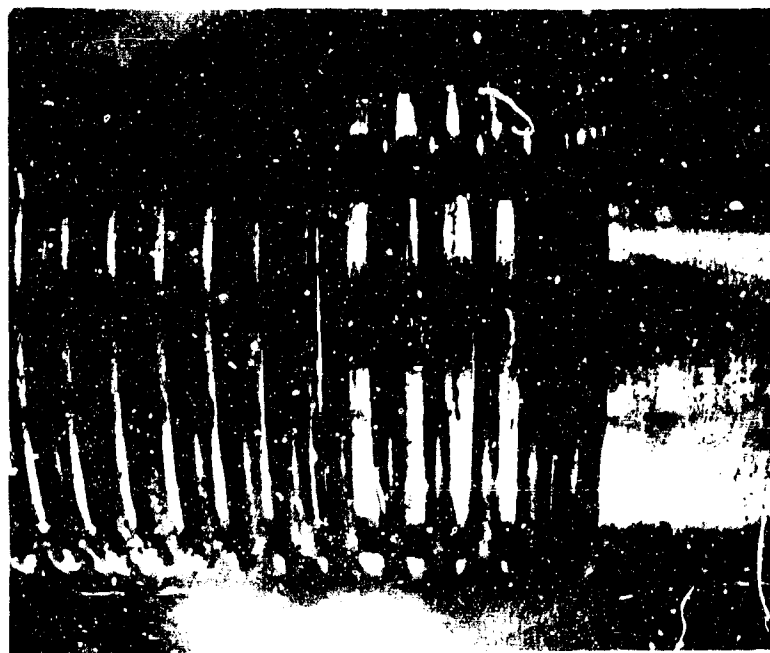
The examination showed severe thread damage on the failed bolts. (Figure 34, 35, and 36). Microscopic examination revealed that failures occurred at the corroded root of the bolt threads. No rust appeared on the shank areas.

Figure 34 Example of Severe Thread Damage of Unfailed Bent Part

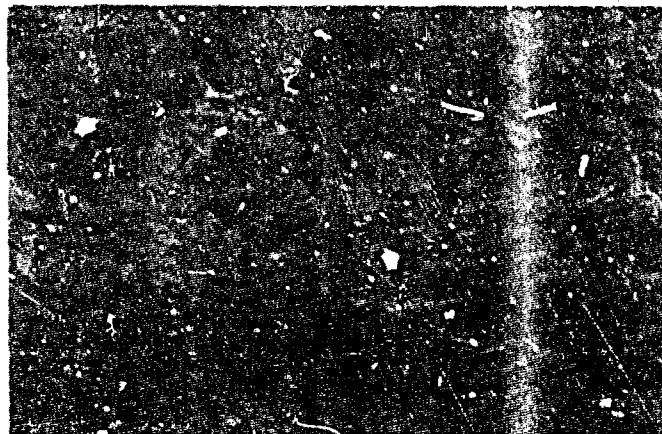
The fracture pattern typical of the area in and around the discolored region pointed out above are shown by the fractographs in Figures 95, 96, and 97. The mechanism of fracture propagation is predominantly quasi-cleavage with occasional evidence of dimpled rupture, the latter indicated in Figure 97. The presence of a smooth corrosion product is also noted by arrows in the figures.

Figure 95 Fractograph Showing Quasi-Cleavage Fracture Mechanism With the Presence of a Smooth Corrosion Product (see arrows).

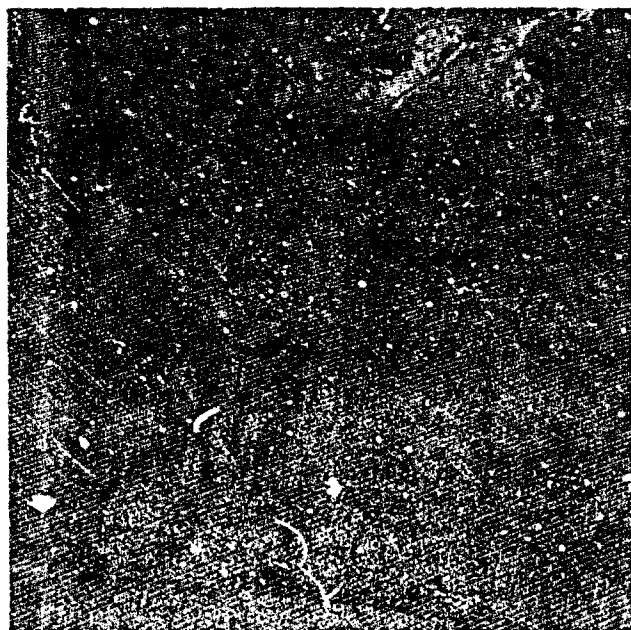
Figure 96 Fractograph Showing Quasi-Cleavage Fracture Mechanism with the Presence of a Smooth Corrosion Product (see arrows).

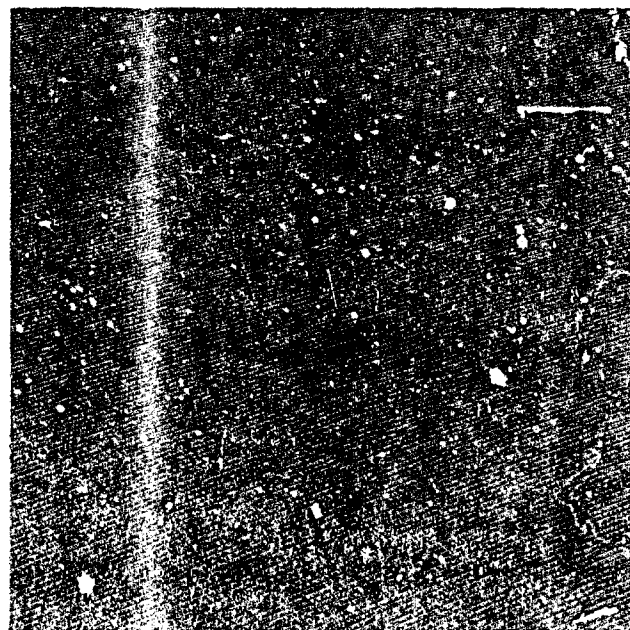
Figure 97 Fractograph Showing a Mixed Quasi-Cleavage and Dimpled Rupture Fracture Mechanism with the Presence of a Smooth Corrosion Product (see arrows).

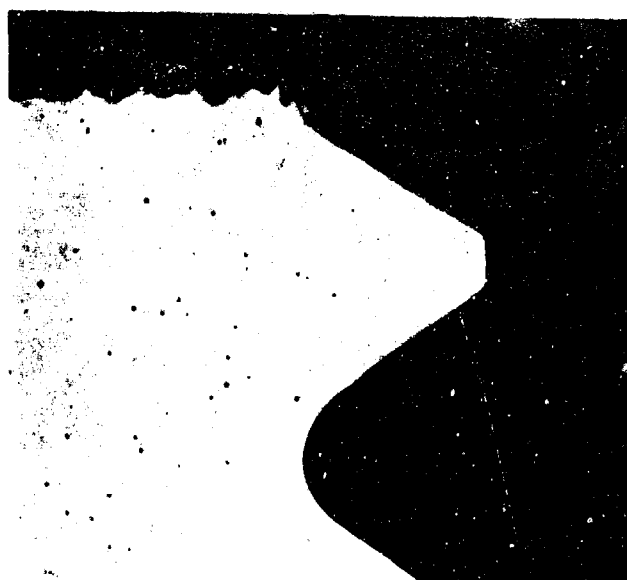
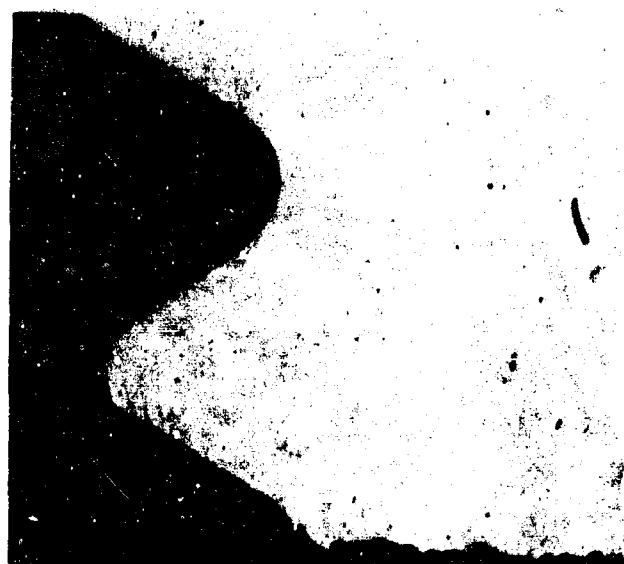
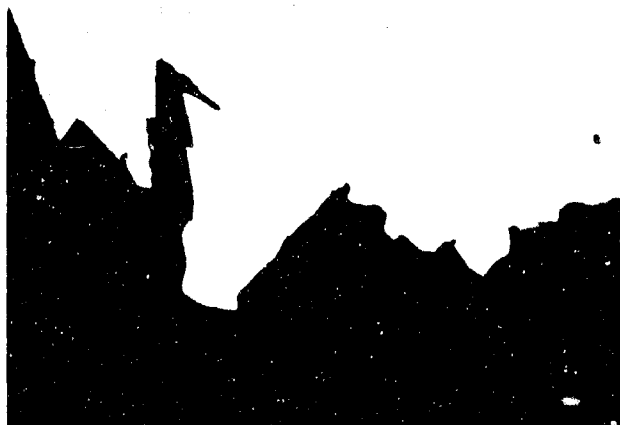
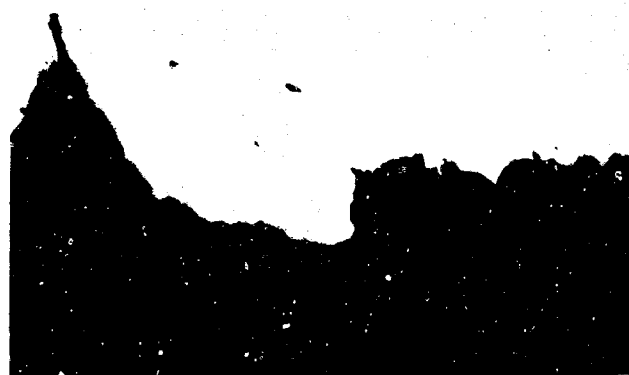
The appearance of the fracture origin, shown in Figure 109 in the etched condition, is given at 100X magnification in Figure 110(a). The deformation zone is readily apparent. Cracks parallel to the direction of elongation in the deformation band associated with the first thread below the fracture in sample LPC 2, is shown in Figure 110(b).

Figure 109- Photomicrographs Showing the Location, (a) and (b), and the Profile, (c) and (d), of the Fracture Origin in Bolt Sample 2.

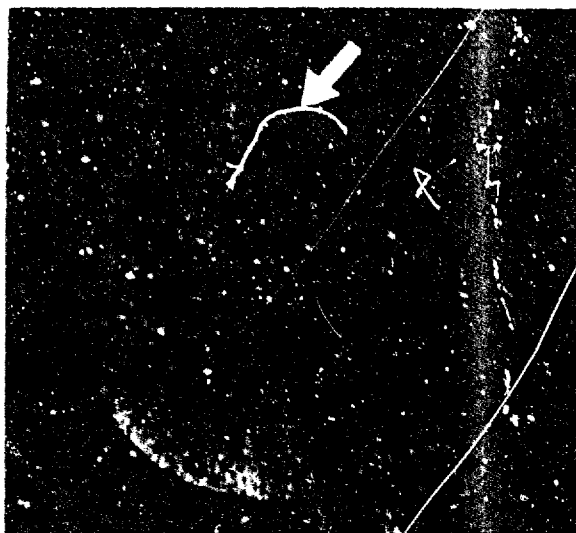
A fractured bolt sent from Rocket Propulsion Laboratory at Edwards Air Force Base by Mr. William Payne was also received at Mellon Institute for the purpose of fractographic analysis. A photograph of the fracture surface is given in Figure 112. Replication was concentrated in the area pointed out by the arrow. This area is characterized by a surface texture much flatter than the rest of the sample.

Figure 112 Photograph of the Fractured Surface of the Bolt Sample Sent From Rocket Propulsion Laboratory. The Arrow Shows the Area of Initial Fracture Where Replication was Conducted.

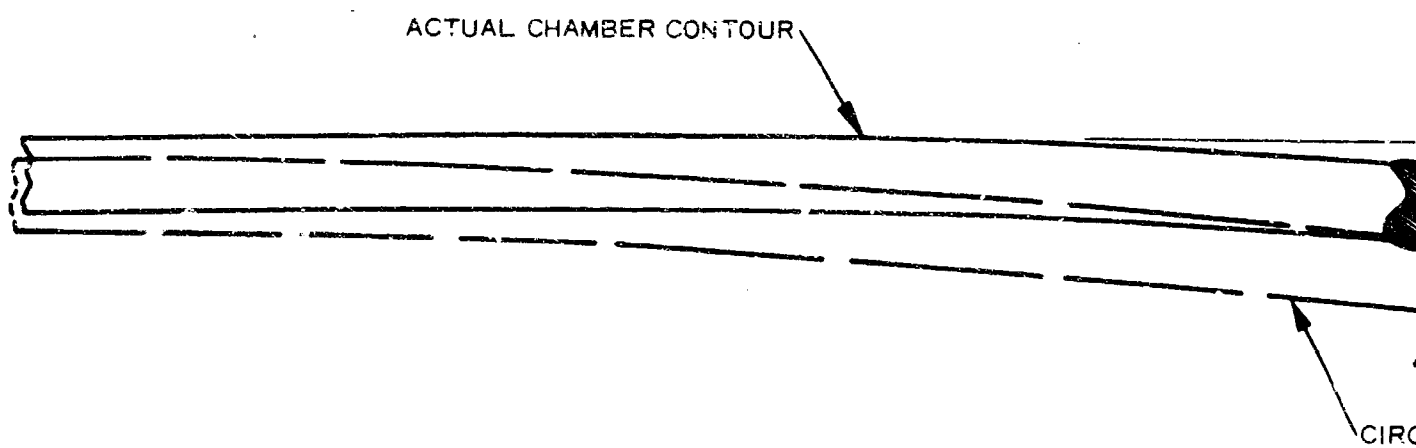
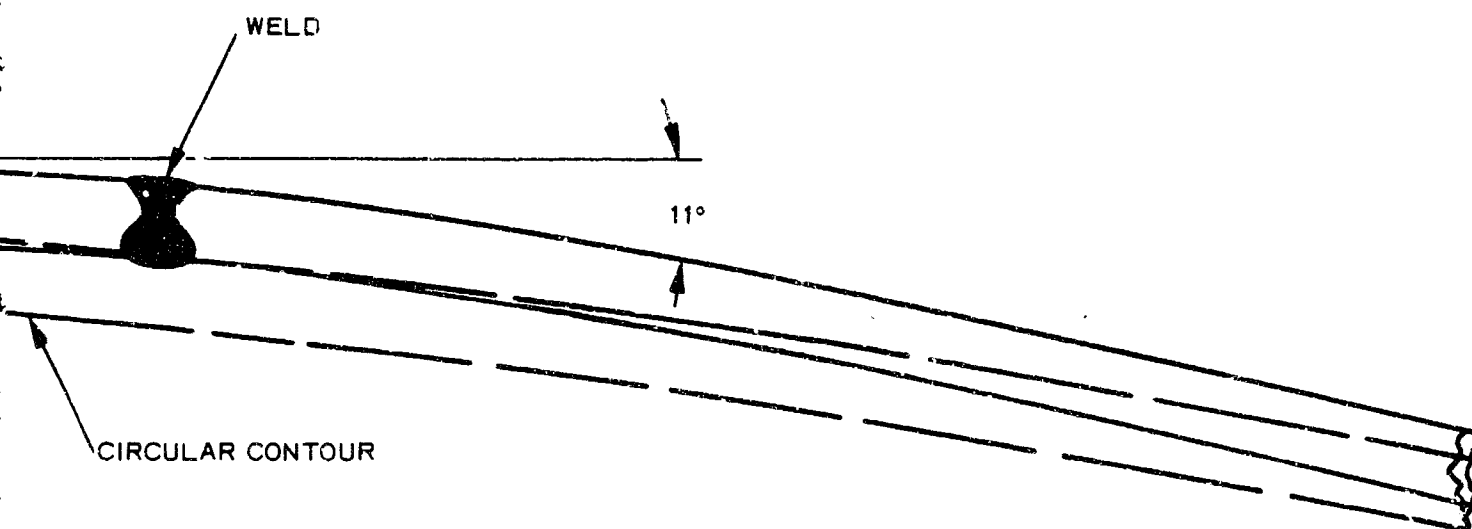
The 156-inch hydroburst program was designed to demonstrate and develop improved methods of performance prediction, including verification of analytical strength analysis methods. The assumptions for the analytical investigation included all visible and experimentally determined defects. Measurements were taken on the case in the region of the longitudinal welds prior to the hydroburst program and compared to similar measurements taken immediately after the case had been fabricated. The differences in the measurements indicated that permanent set had occurred in the interim. The most severe discontinuity in the 156-inch case was a circumferential angular mismatch as shown in Figure 119.

The most severe discontinuity in the longitudinal weld based on measured data is shown in Figure 119.

Figure 119 Typical Contour  
Measurement  
Depicting Peaking

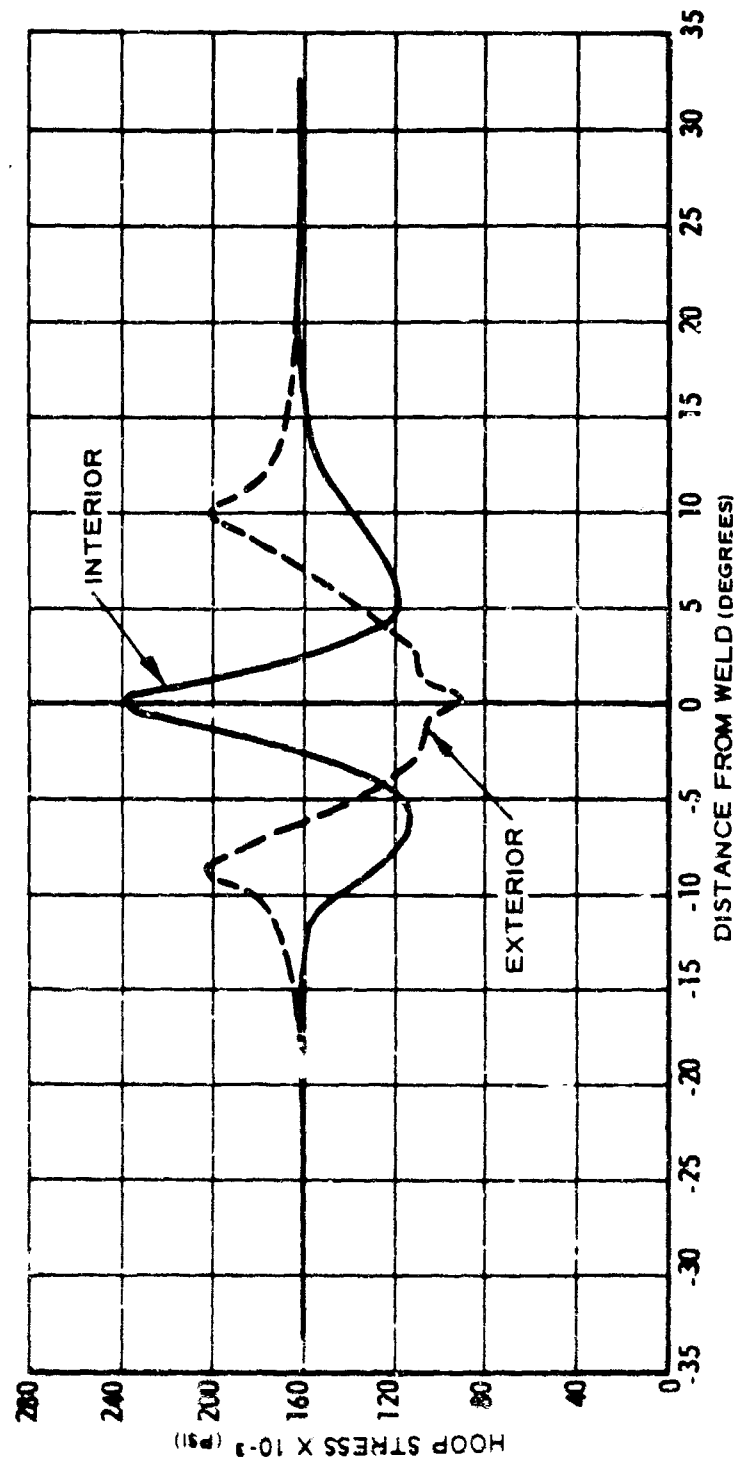
The discontinuity stress analysis shows that failure would not occur due to the irregular shape of the chamber. The Nonlinear Plane Strain Program No. 287 was used to analyze the chamber's most severe discontinuous cross-section; the results are presented in Figure 126, where the hoop stresses versus circumferential position are plotted. The analysis showed significant effects of bending and shear stresses in the chamber.

The area chiefly suspected of possible failure was in the bolts. Post-hydroburst inspection of the bolts showed indications of environment deterioration. The Shell of Revolution Program 124 (see Appendix) was used to analyze the loading on the closure forging due to discontinuity stress resultants. The analysis showed a basic bolt load of 44,625 pounds per bolt

Figure 126 Hoop Stress versus Circumferential Position  
at Point of Greatest Discontinuity

and 13,985 pounds per bolt due to the interface loads at a pressure of 1038 psi. Comparing these loads with the listed properties of the  $\frac{3}{4}$ -16 UNF bolts (Ref. ), the minimum margin of safety is 0.76. At 800 psi, the calculated margin of safety is 1.28; however, a stress of 50% of the proportional limit or greater, as discussed in Section V, is sufficient to produce stress corrosion failure under specific conditions.

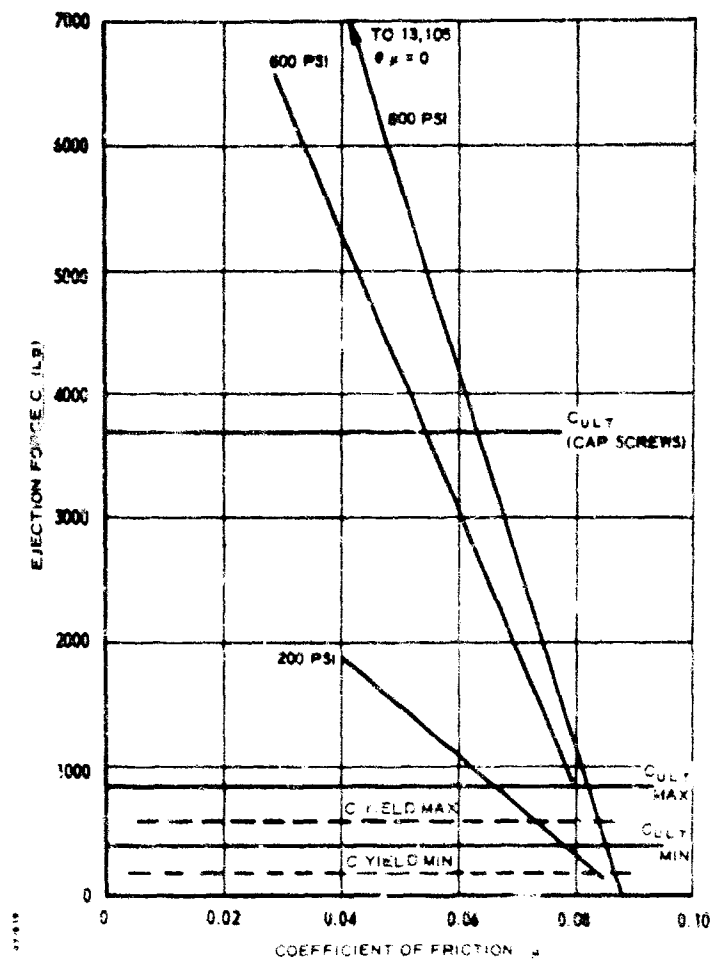
The case consisted of two segments attached by 200 pin clevis joints. The ejection loads on the pins were determined for various levels of pressure loading from 200 psi to 800 psi and are plotted in Figure 127.

The load calculated to fail the retainer bars is 396 pounds, minimum; 857 pounds, maximum. These loads correspond to anticipated ejection loads for static friction coefficients of 0.085 to 0.082. It is also necessary to keep in mind that dynamic coefficients of friction are much lower than static. The lack of the empirical dynamic data suggests that rapid rate (vibration) tensile tests should be initiated. Calculations for the tapered pin joint are shown in the appendix, subsection 8.

Figure 127 Ejection Force versus Coefficient of Friction

- (4) To evaluate the assumptions on dynamic ejection of the pins, it is recommended that laboratory tests be performed to simulate those conditions in the motor. Simple pin extraction under rapid-rate vibration and analog tests of the assemblage would give better foundation for analytic assumptions.

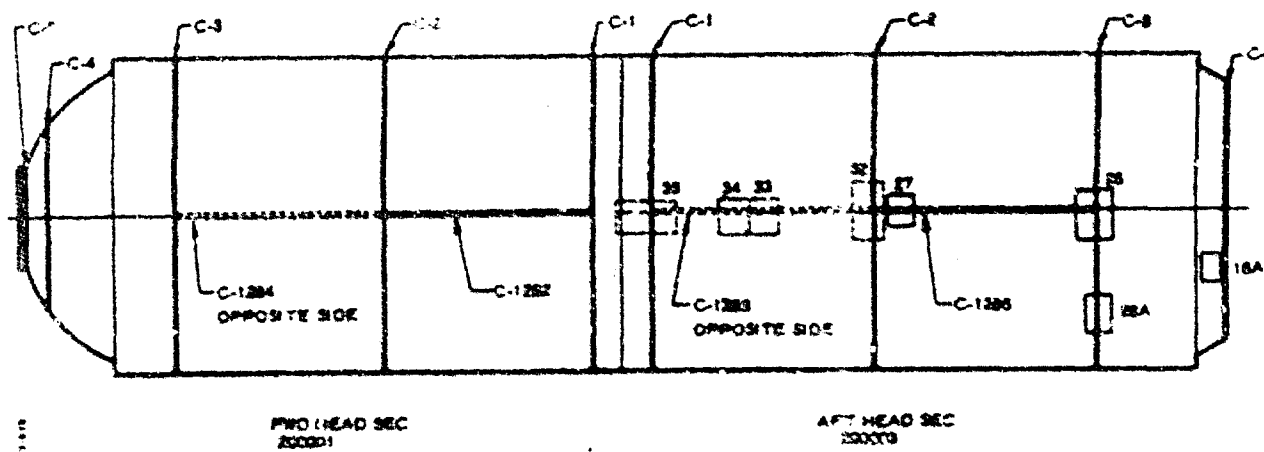
After hydroburst, test plates were removed from the damaged aft-head section by carbon-arc cutting. The plates contained representative ultrasonic indications detected during the pre-hydroburst inspections. The areas from which the plates were removed and plate identification are shown in Figure 136. After removal of the plates from the case section they were solvent cleaned to remove the old liner and insulation materials so that additional ultrasonic testing could be accomplished from both side of the plate.

Figure 136 156-Inch Diameter Hydroburst Weld Identification and Test Plate Location (Post-Hydroburst)

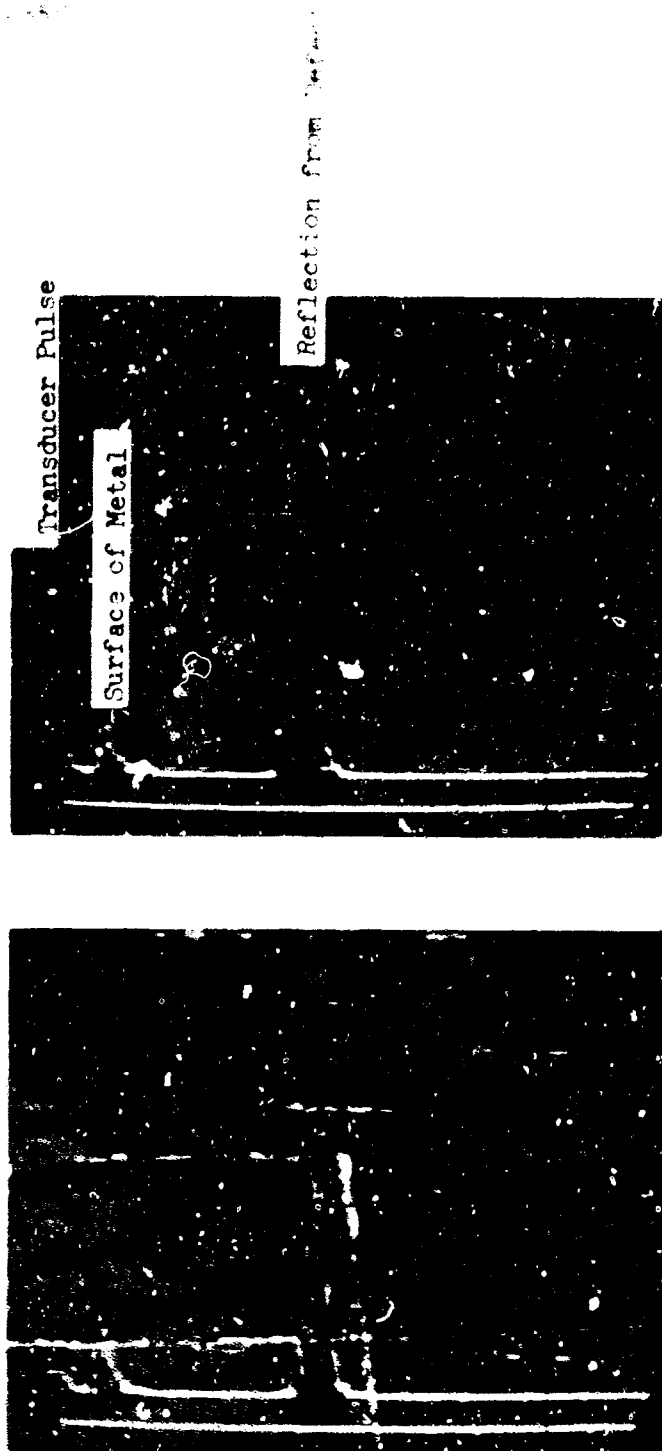
Top and bottom photos are  
 with transducer at 90° to weld      Bottom photo  
 with transducer on the weld bead parallel to the bead.  
 0.25 mc transducer -  $\frac{1}{2} \times \frac{1}{2}$ " crystal  
 60° shear angle

Figure 157 Shear Wave Indication From 32-3

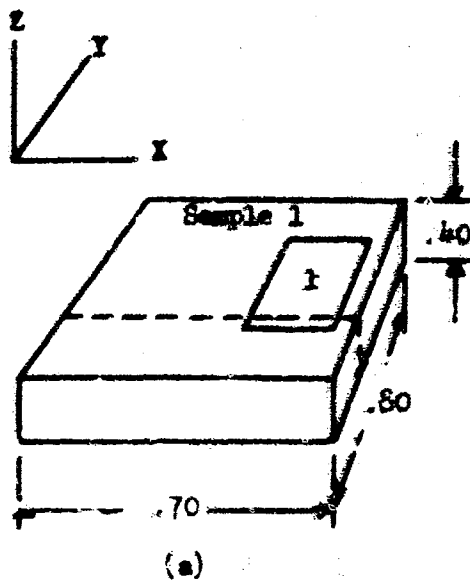
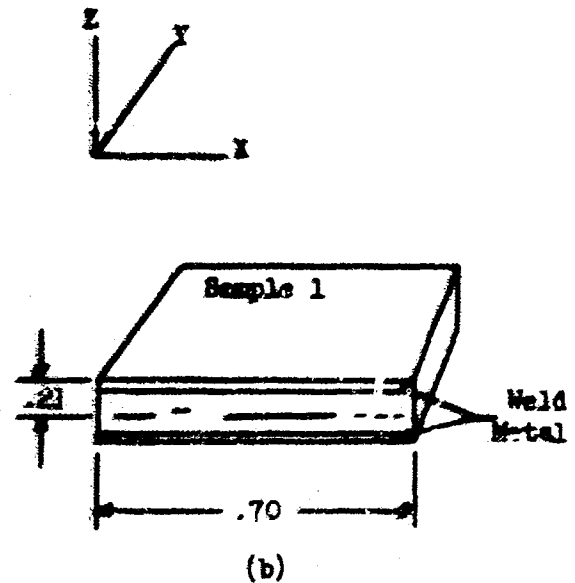
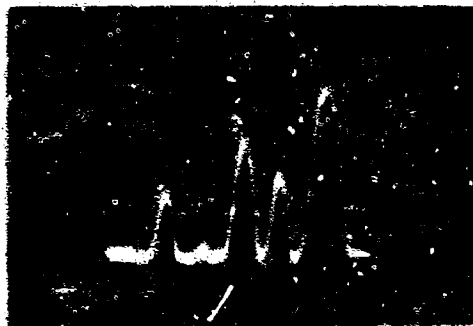
All defects were thin delaminations generally located in one plane which was parallel to the sample surfaces and located approximately equidistant from them.

All delaminations examined were associated with a banded microstructure and stringers of secondary phase particles.

Figure 151 "Lead-Off" Page for Sample 1 Showing (a) a Sketch of the Sample, (b) a Sketch of the Sectioned Metallographic Specimen, (c) an Oscillograph Display of the Defect, and (d) a Photomicrograph of the "Most Open" Portion of the Crack.

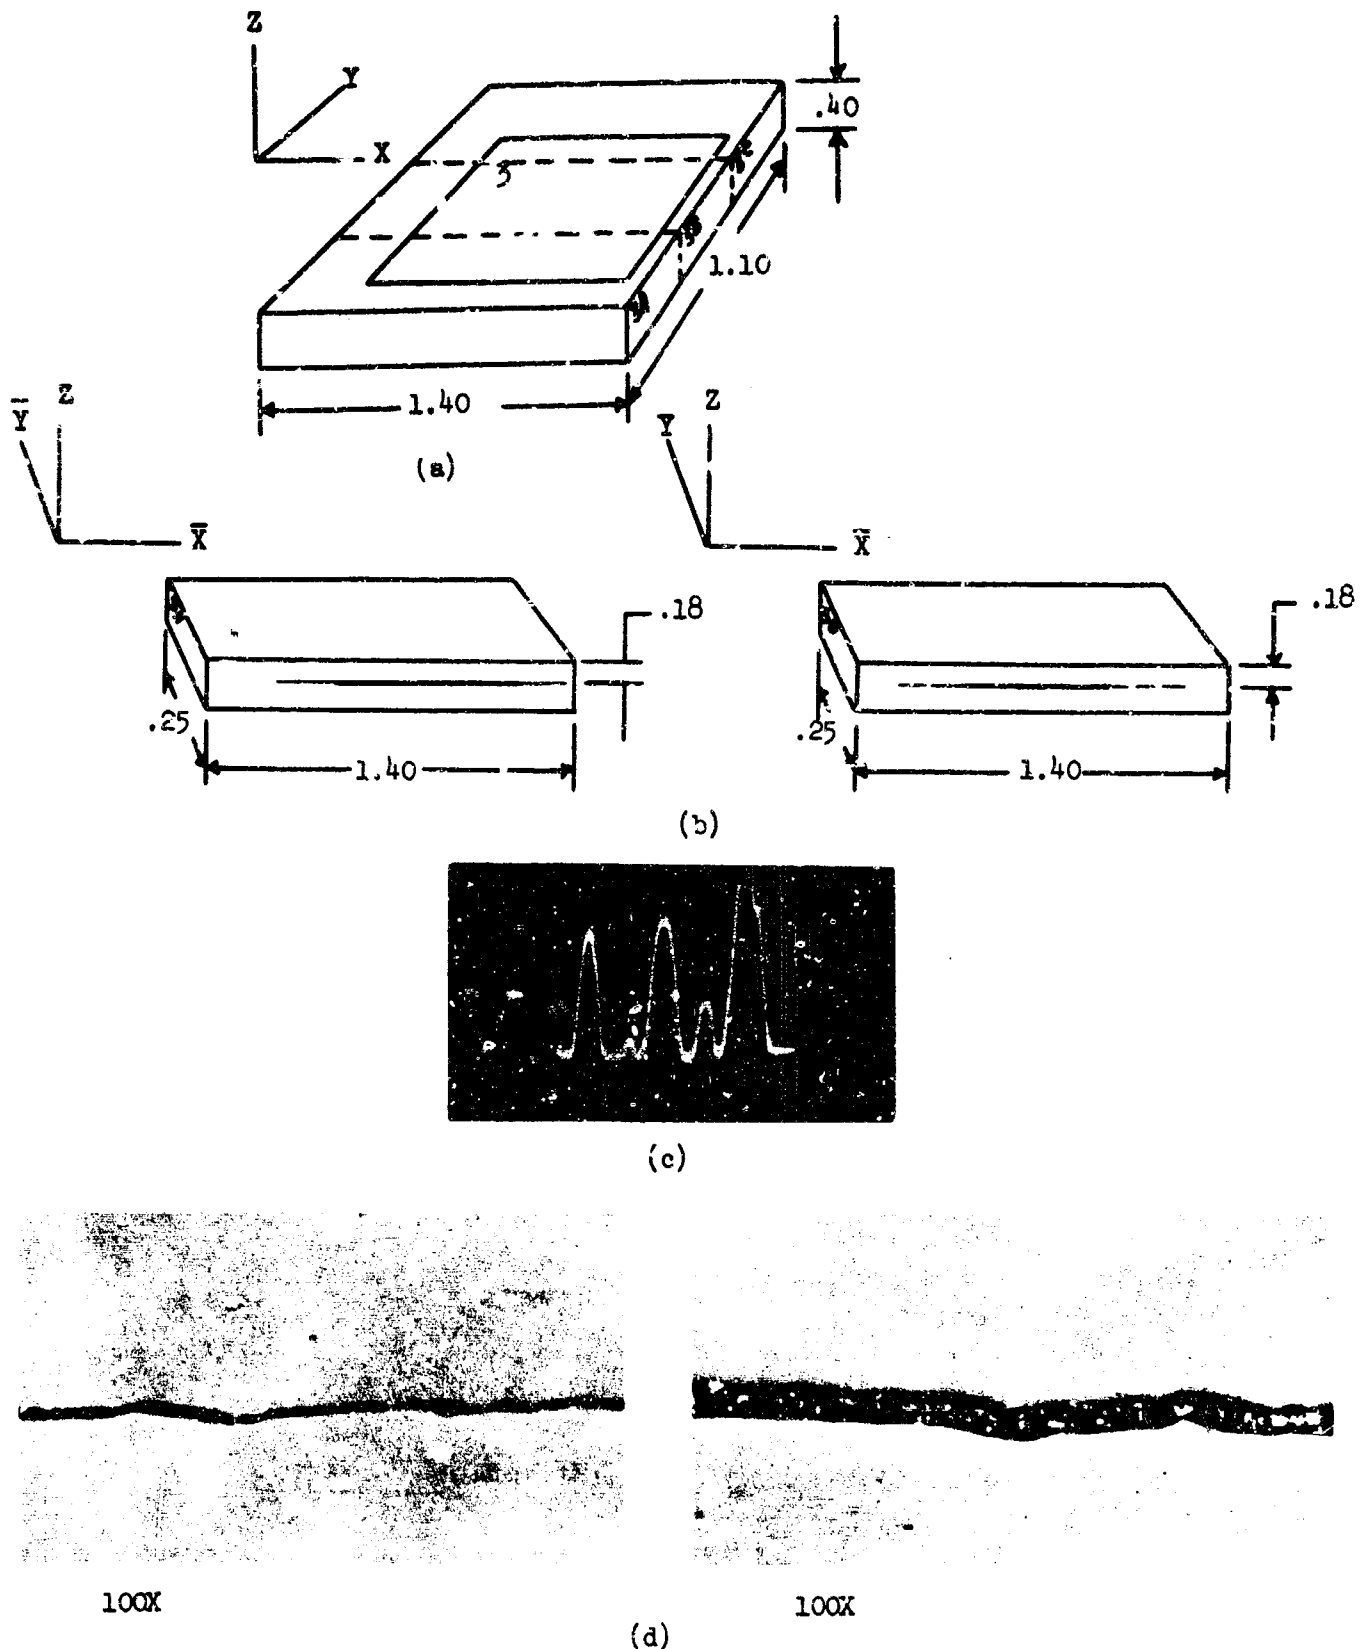
Figure 153 "Lead-Off" Page for Sample 3 Showing (a) a Sketch of the Sample, (b) Sketches of the Section Metallographic Specimens, (c) an Oscilloscope Display of the Defect, and (d) Photomicrographs of the "Most Open" Portion of the Cracks in Specimens 3A and 3B, Respectively

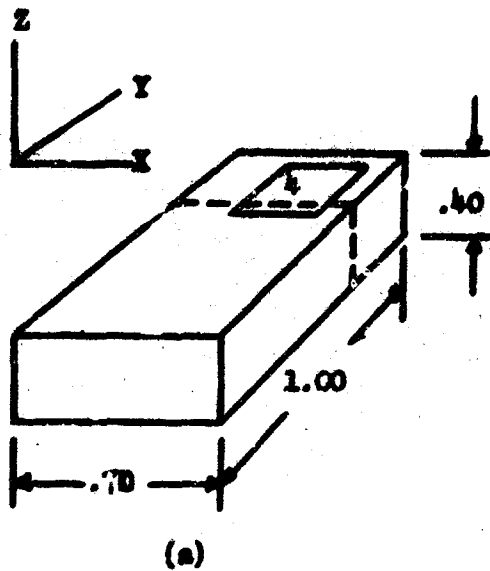
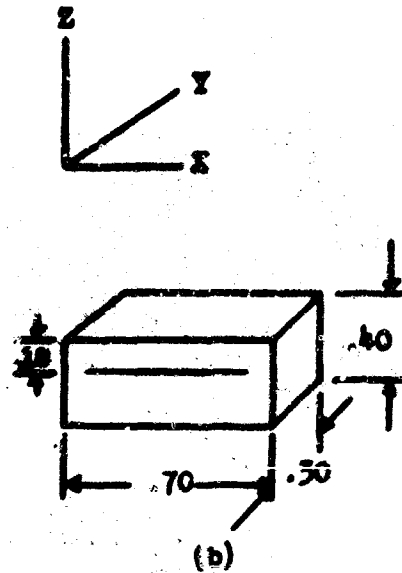
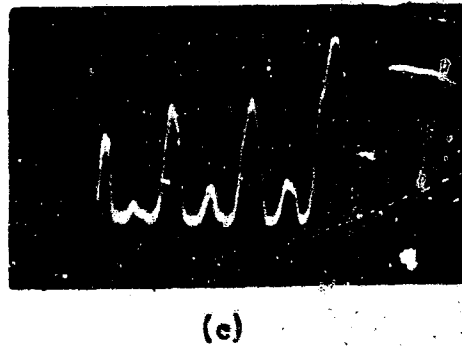
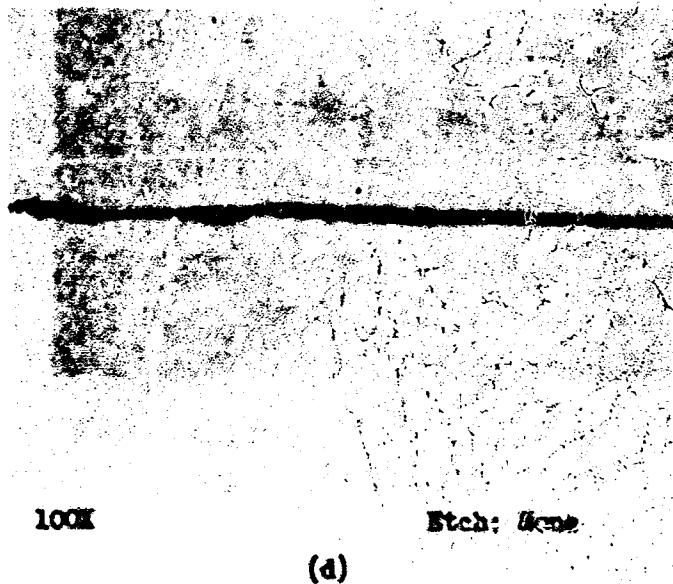
Figures 151 through 165 present sketches, oscillograph displays, and photomicrographs showing the qualitative results of the inspection. Figures 151, 153, 158, 160, and 163 are "lead-off" pages to each one of the five samples in which defects were found of the total of six received at Mellon Institute. These figures include (a) sketches of the as-received samples and the manner in which they were sectioned (dotted lines), (b) sketches of the resulting metallographic samples, (c) oscillograph displays of the charted defects, and (d) a photomicrograph of the "most open" portion of the crack.

Figure 158 "Lead-Off" Page for Sample 4 Showing (a) a Sketch of the Sample, (b) a Sketch of the Sectioned Metallographic Specimen, (c) an Oscillograph Display of the Defect, and (d) a Photomicrograph of the "Most Open" Portion of the Crack

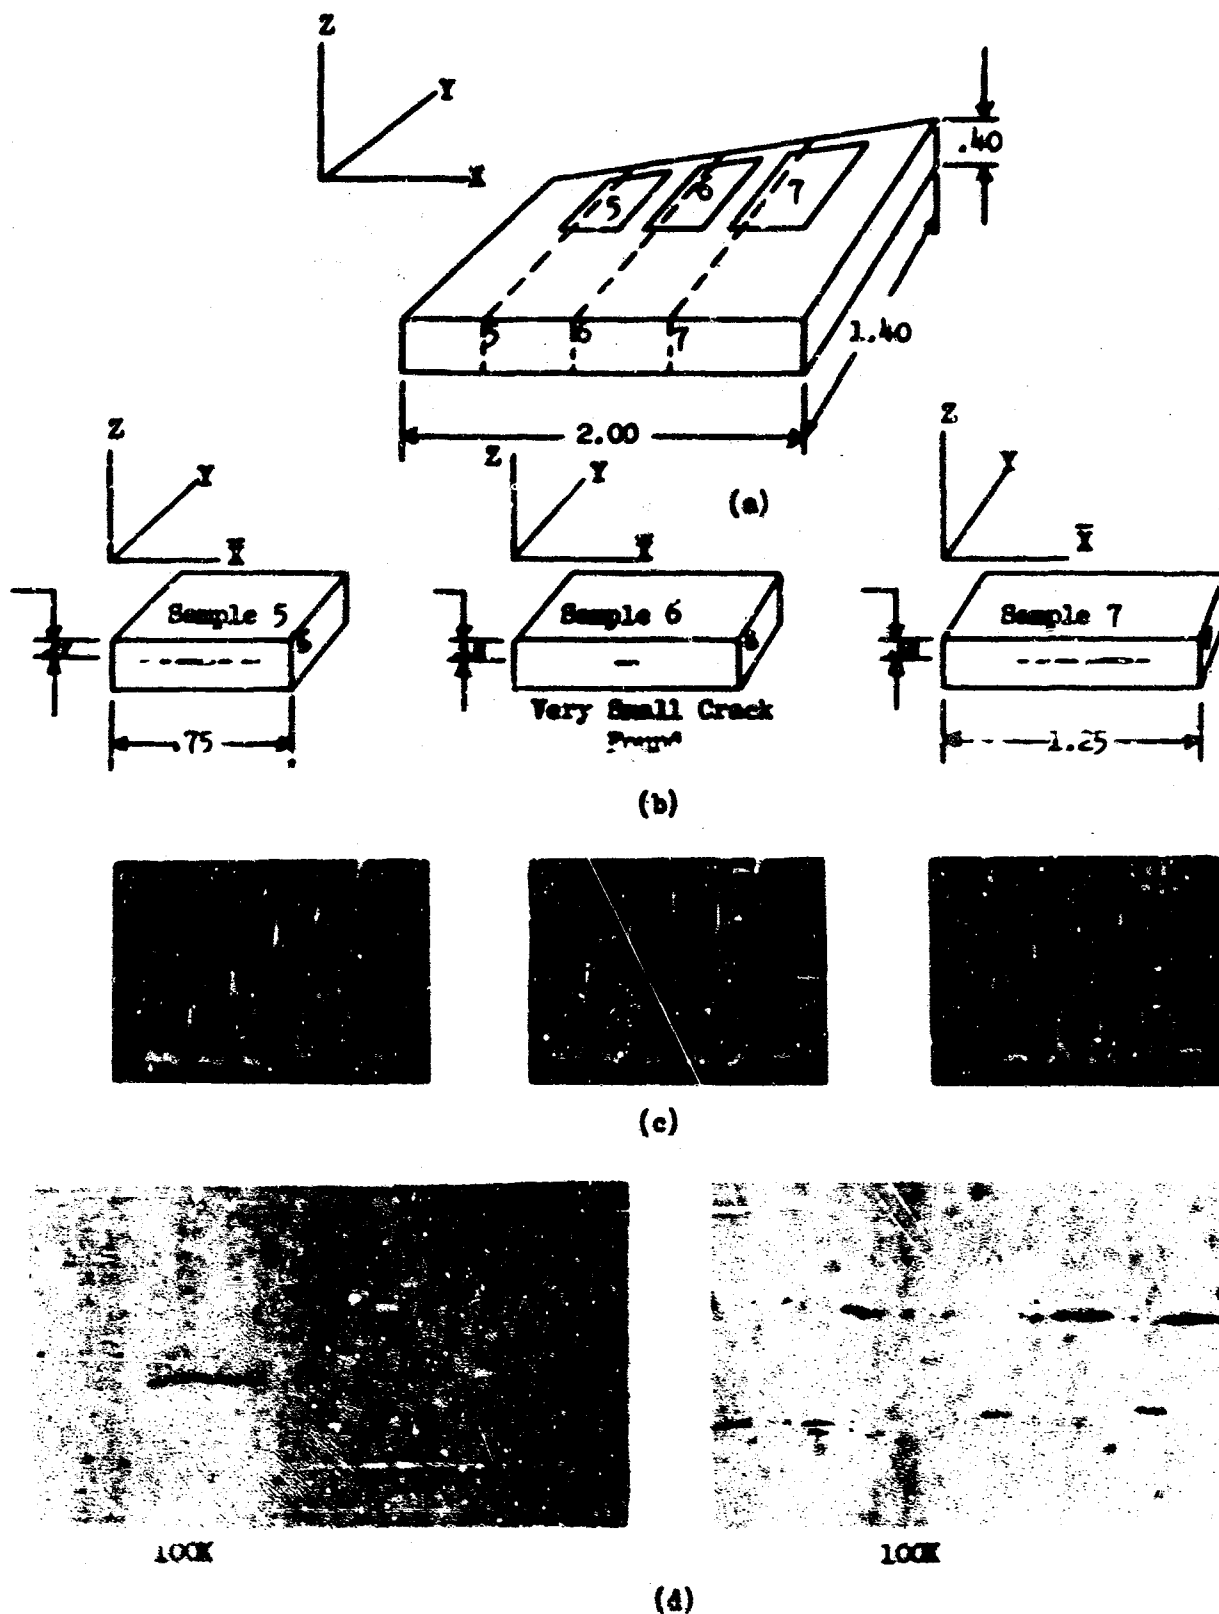
Figure 160 "Lead-Off" Page for Combination Sample 5, 6 and 7 Showing (a) a Sketch of the Sample, (b) Sketches of the Corresponding Metallographic Specimens, (c) an Oscilloscope Display of the Defects, and (d) Photomicrographs of the "Most Open" Portion of the Cracks in Specimens 5 and 7, Respectively

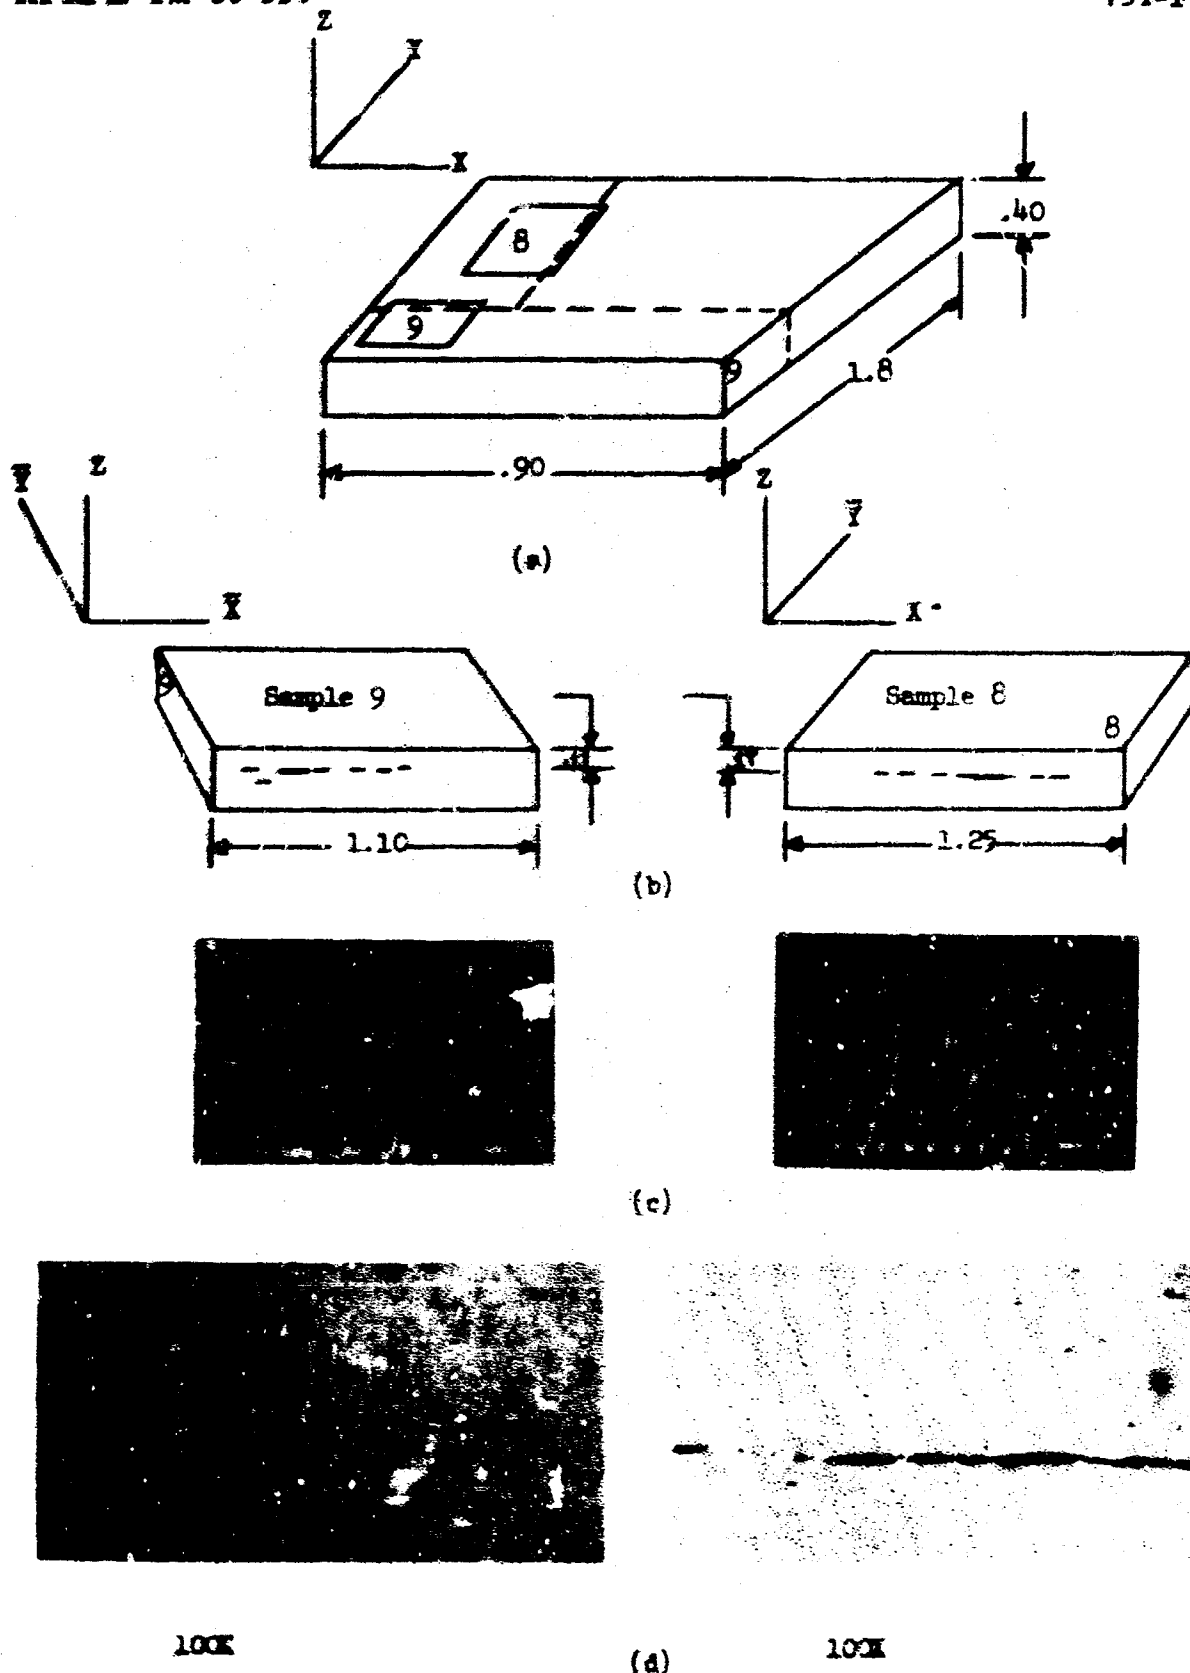
Figure 163 "Lead-Off" Page for Combination Sample 8 and 9 Showing (a) a Sketch of the Sample, (b) Sketches of the Sectioned Metallographic Samples, (c) an Oscillographic Display of the Defects, and (d) Photomicrographs of the "Most Open" Portion of the Crack in Samples 9 and 8, Respectively
